**UNDERWATER FACILITIES
INSPECTIONS
AND
ASSESSMENTS
AT

U.S. NAVAL STATION

ROOSEVELT ROADS, P.R.**

FEBRUARY 1982

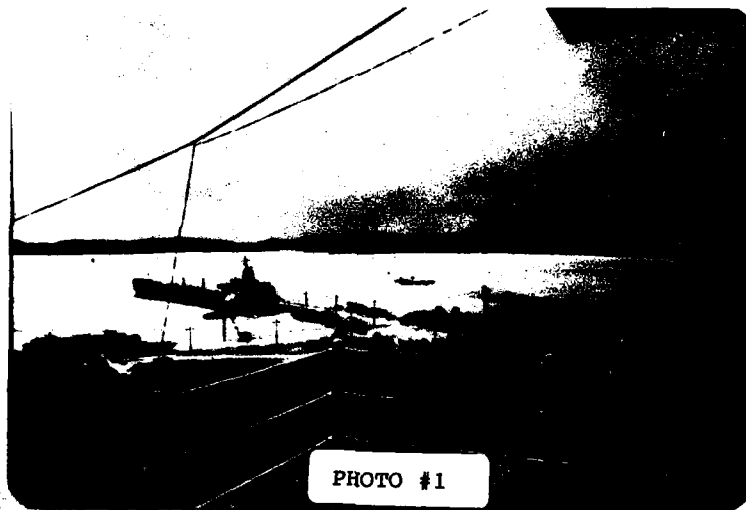
PHOTO #1: View of Fuel Pier (266)
from the Naval Station

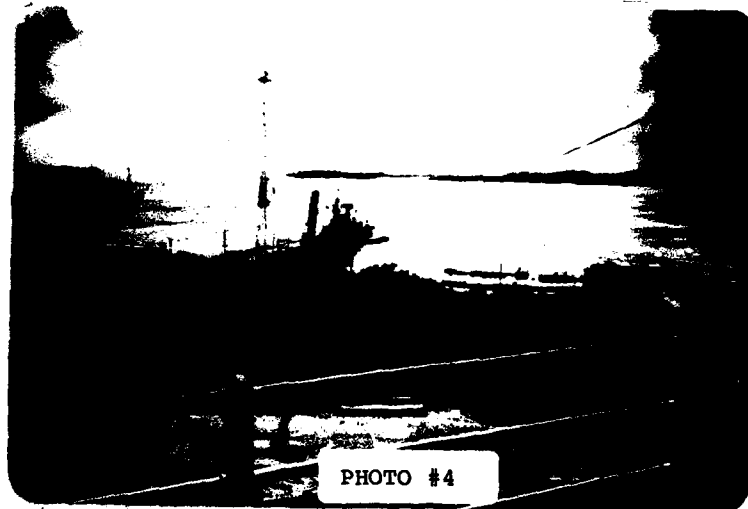
PHOTO #4: View of Supply Pier (267)
from the Naval Station

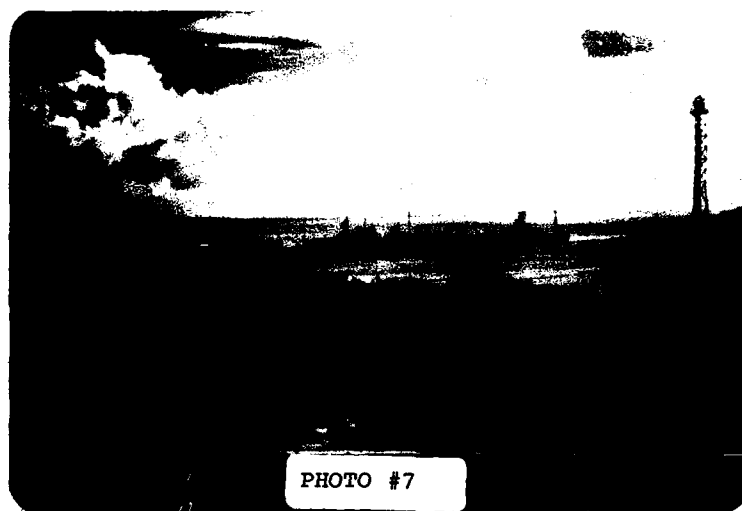
PHOTO #7

PHOTO #7: View of Berthing Pier (799)
and Section C of Berthing
Wharf (890) from the Naval
Station

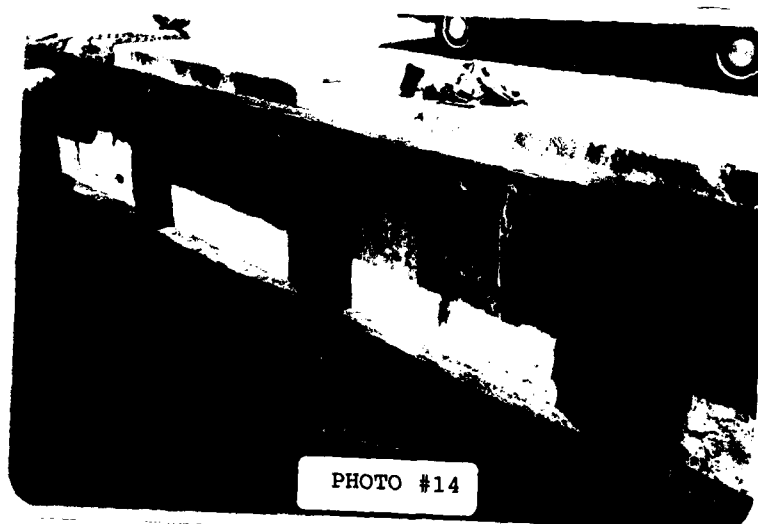
PHOTO #14: View of Concrete Encasement
and Fender System in Section A
of the Berthing Wharf (890),
Showing Typical Conditions

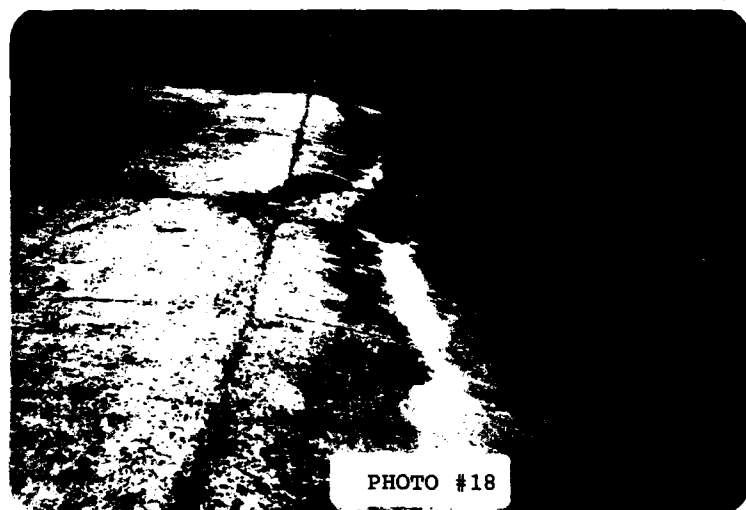
PHOTO #18: Spalled and Broken Area of
Concrete Slab in Center of
LST Ramp (843)

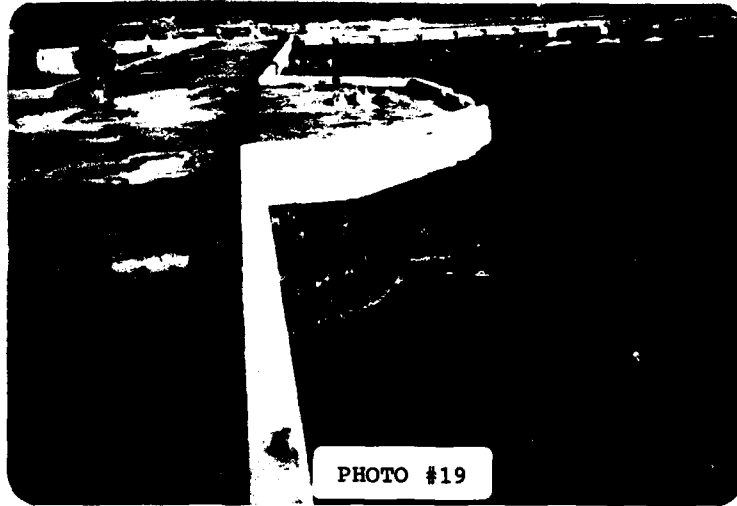
PHOTO #19: View of Deck and Cylinder B1,
Looking Inshore Along Northeast
Edge of the Approach Pier (273).
Note Corrosion of Steel Sheet
Piling in Splash Zone (Typical
Condition)

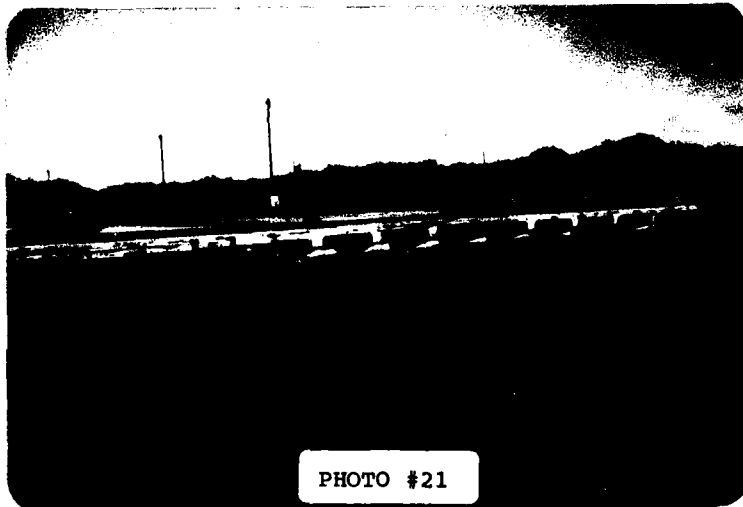
PHOTO #21: View of Face of North Quaywall
of Small Craft Berth (844).
